Oregon Water Quality Index Data Summary Water Years 2015-2024

June 2025

DEQ25-LAB-0028-TR Version 1.0 Last updated: 6/05/2025

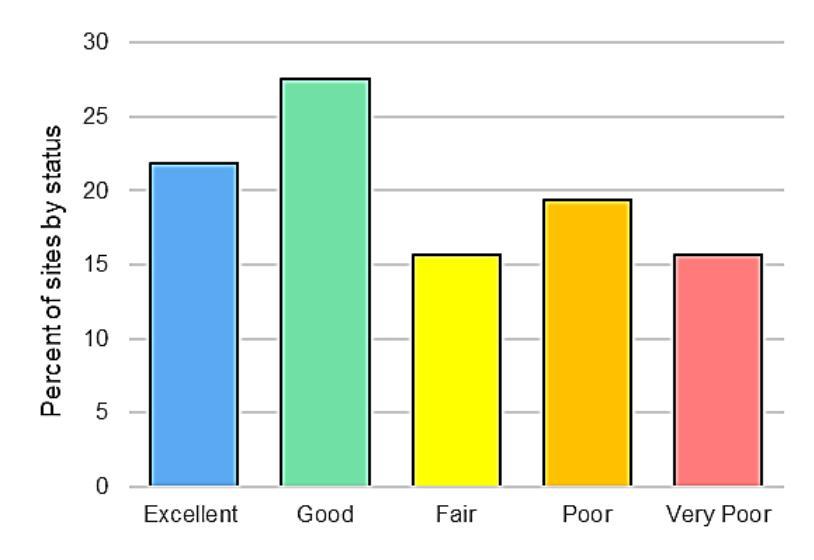
Figure 1. Percent of sites with scores in each Oregon Water Quality Index status.

Oregon Water Quality Index results for water years 2015-2024 show 49 percent of sites in excellent or good status, 16 percent in fair and 35 percent in poor or very poor status for the statewide ambient monitoring network of 160 sites (Figure 1). Three sites reported in 2015 and 2016 were part of a special study and were dropped from the ambient network at the completion of the study. These three sites were Willow Creek at Heppner Junction (10708), Fifteenmile Creek at Boyd Market Rd (12550) and John Day River at Clyde Park (31990).

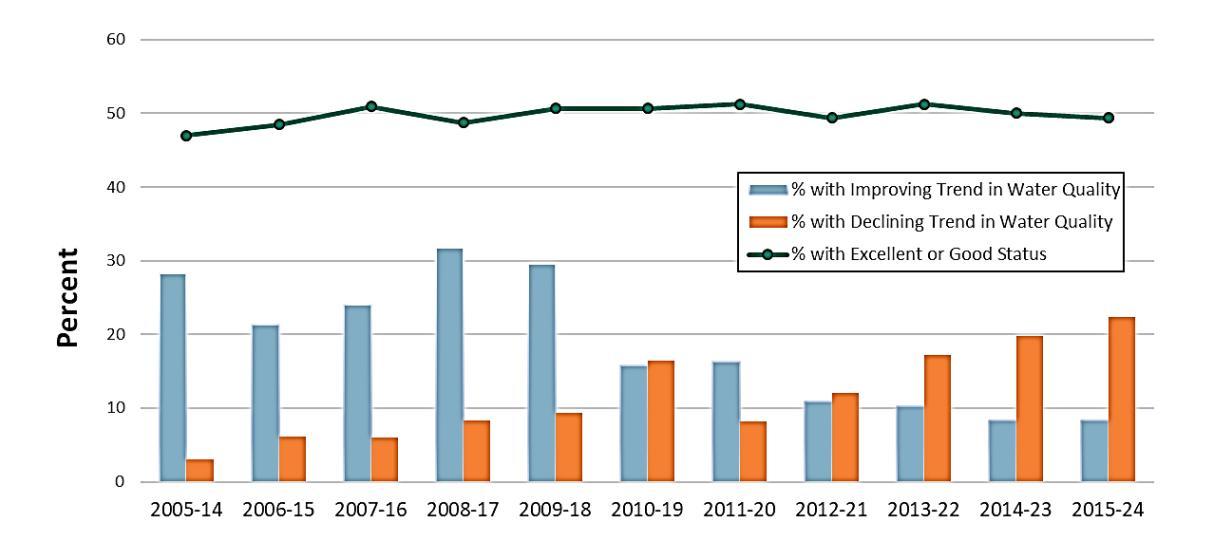
Figure 2. Percentages of sites with Improving or Declining trends and the percentage of sites with Excellent or Good status by OWQI reporting period, over the last ten years. Sites determined to have no trend in a reporting period are not shown.

A trend analysis was completed for 157 of the 160 sites. Of the locations where a trend analysis could be completed, 8 percent showed an Improving trend in water quality, while 22 percent had a Declining trend in water quality (Figure 2). The remaining 70 percent of sites have no statistically significant trend. Of the sites with improving trends, 85 percent are categorized as Fair to Very Poor status. This is up from 38 percent last year. On the other hand, 54 percent of the sites identified with Declining water quality remain categorized as Excellent or Good status. Those locations should be evaluated further to avoid a continuing decrease in water quality status. The Skipanon River at Highway 101, Crooked Creek at Kiger Road, and South Fork Blitzen River at Blitzen Crossing monitoring locations did not have the required 30 or more scores in this data window to calculate a trend. Specifically, the Skipanon River site is tidally influenced, and high conductivity samples are not included in the analysis because they do not accurately reflect ambient water quality as this study is intended. The Blitzen River and Crooked Creek sites are two of the most remote locations in the ambient network. They were difficult to access during large portions of the year.

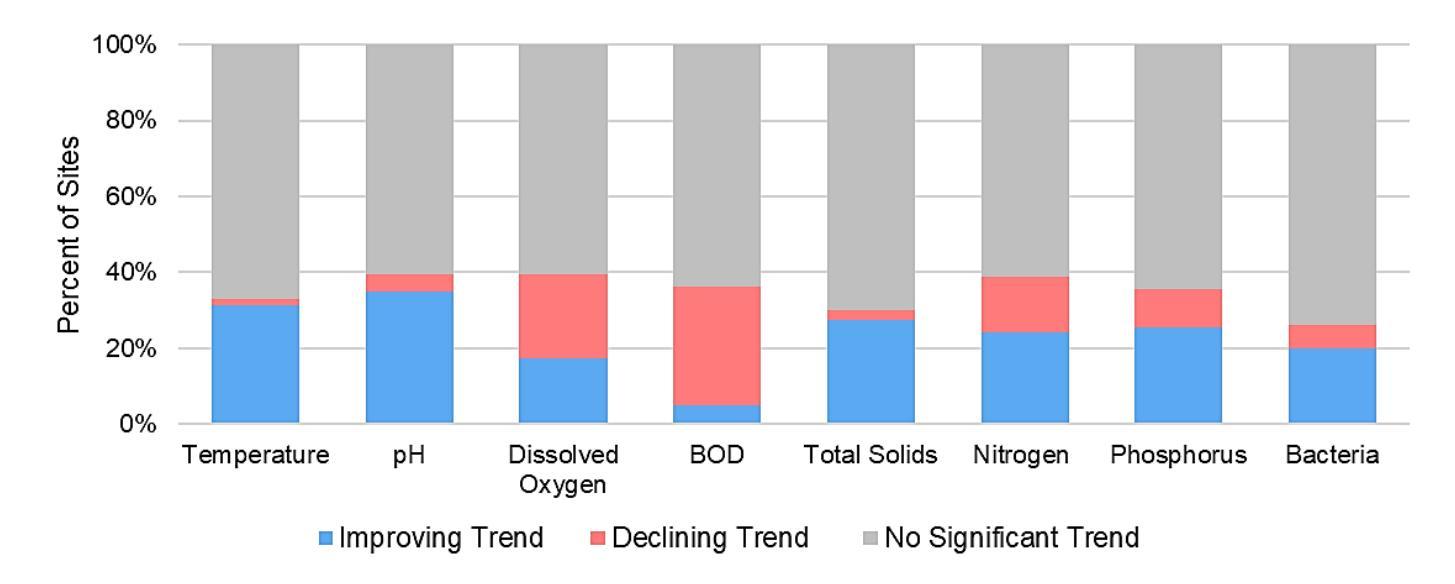
Figure 3. Sub-index trends for the 2024 water year (Oct. 1, 2015 to Sept. 30, 2024).

Trend analysis of water year 2024 data indicates that pH had the highest percentage of Improving sub-index scores at 35 percent (Figure 3). This year continues last year's trend of Declining subindex scores. It is the second year in a row with over 20 percent of ambient monitoring sites having Declining subindex scores across all parameters. Prior to 2023, the last year the percentage of Declining subindex scores was above 20 percent was 2011. The analysis performed on 2024 data showed a one percent increase in Improving trends from the 2023 OWQI reporting period. This was the same percent increase documented in the 2023 OWQI (one percent increase in improving trends between 2022 and 2023).

BOD had the highest percentage of Declining sub-index scores followed by dissolved oxygen, nitrogen and phosphorous. Although there were 49 Declining sub-index trends for BOD this year, there were six fewer Declining BOD trends than in the 2023 OWQI. Most of the stations with Declining BOD trends in 2024 were in the Forest Land Use type, whereas most Declining BOD trends in the 2023 OWQI were in the Agriculture land use type. There were 35 Declining DO sub-index trends in the 2024 OWQI, which is 17 more than in the 2023 OWQI reporting period.

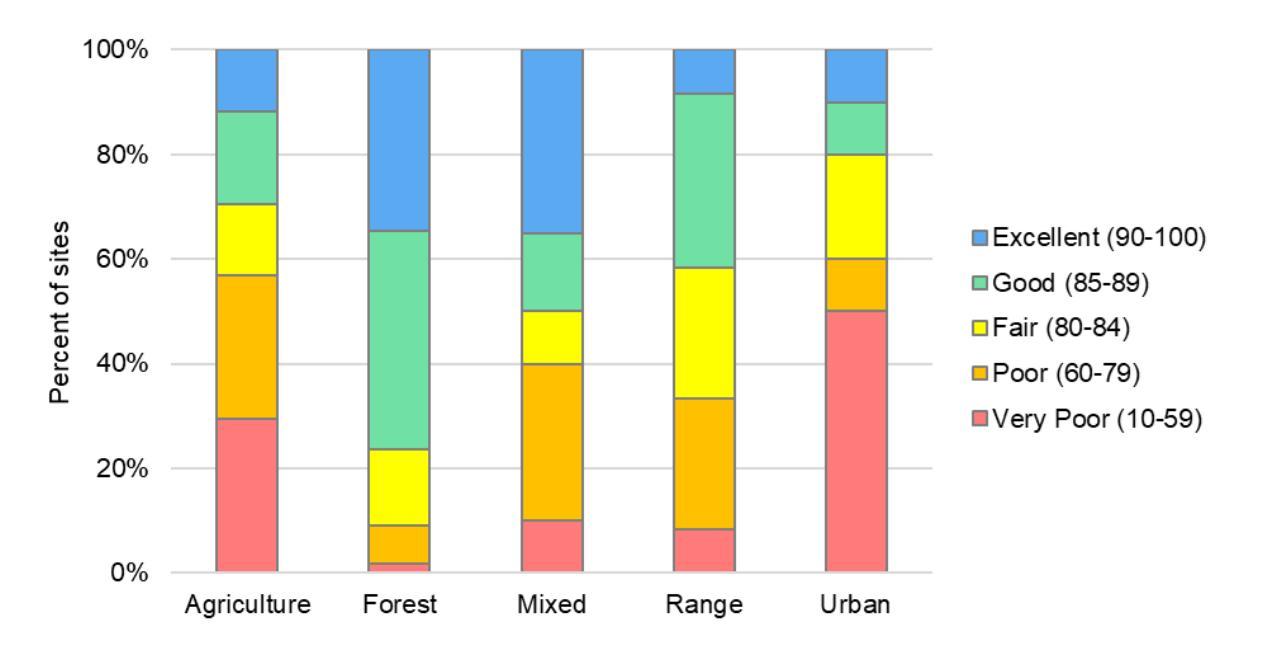
Although the Forest Land Use site had the largest number of Declining trends, it continued to have the highest percentage of Excellent and Good status sites. (Figure 4). There were few updates in the changes in status across land use type between the 2023 and 2024 reporting period. The 2024 reporting period is the third consecutive year with at least 40 percent of sites in the range land use type had a status of excellent or good. Also, this is the sixth consecutive year stations with the Forest Land Use type have had a significant decline in trends, with 2021 showing the greatest change from the prior reporting year.
