## BURNS PUMICE

## HARNEY COUNTY

Burns Pumice

Foreword: This is a supplement report to a report under the above title by John Allen, April 22, 1941.

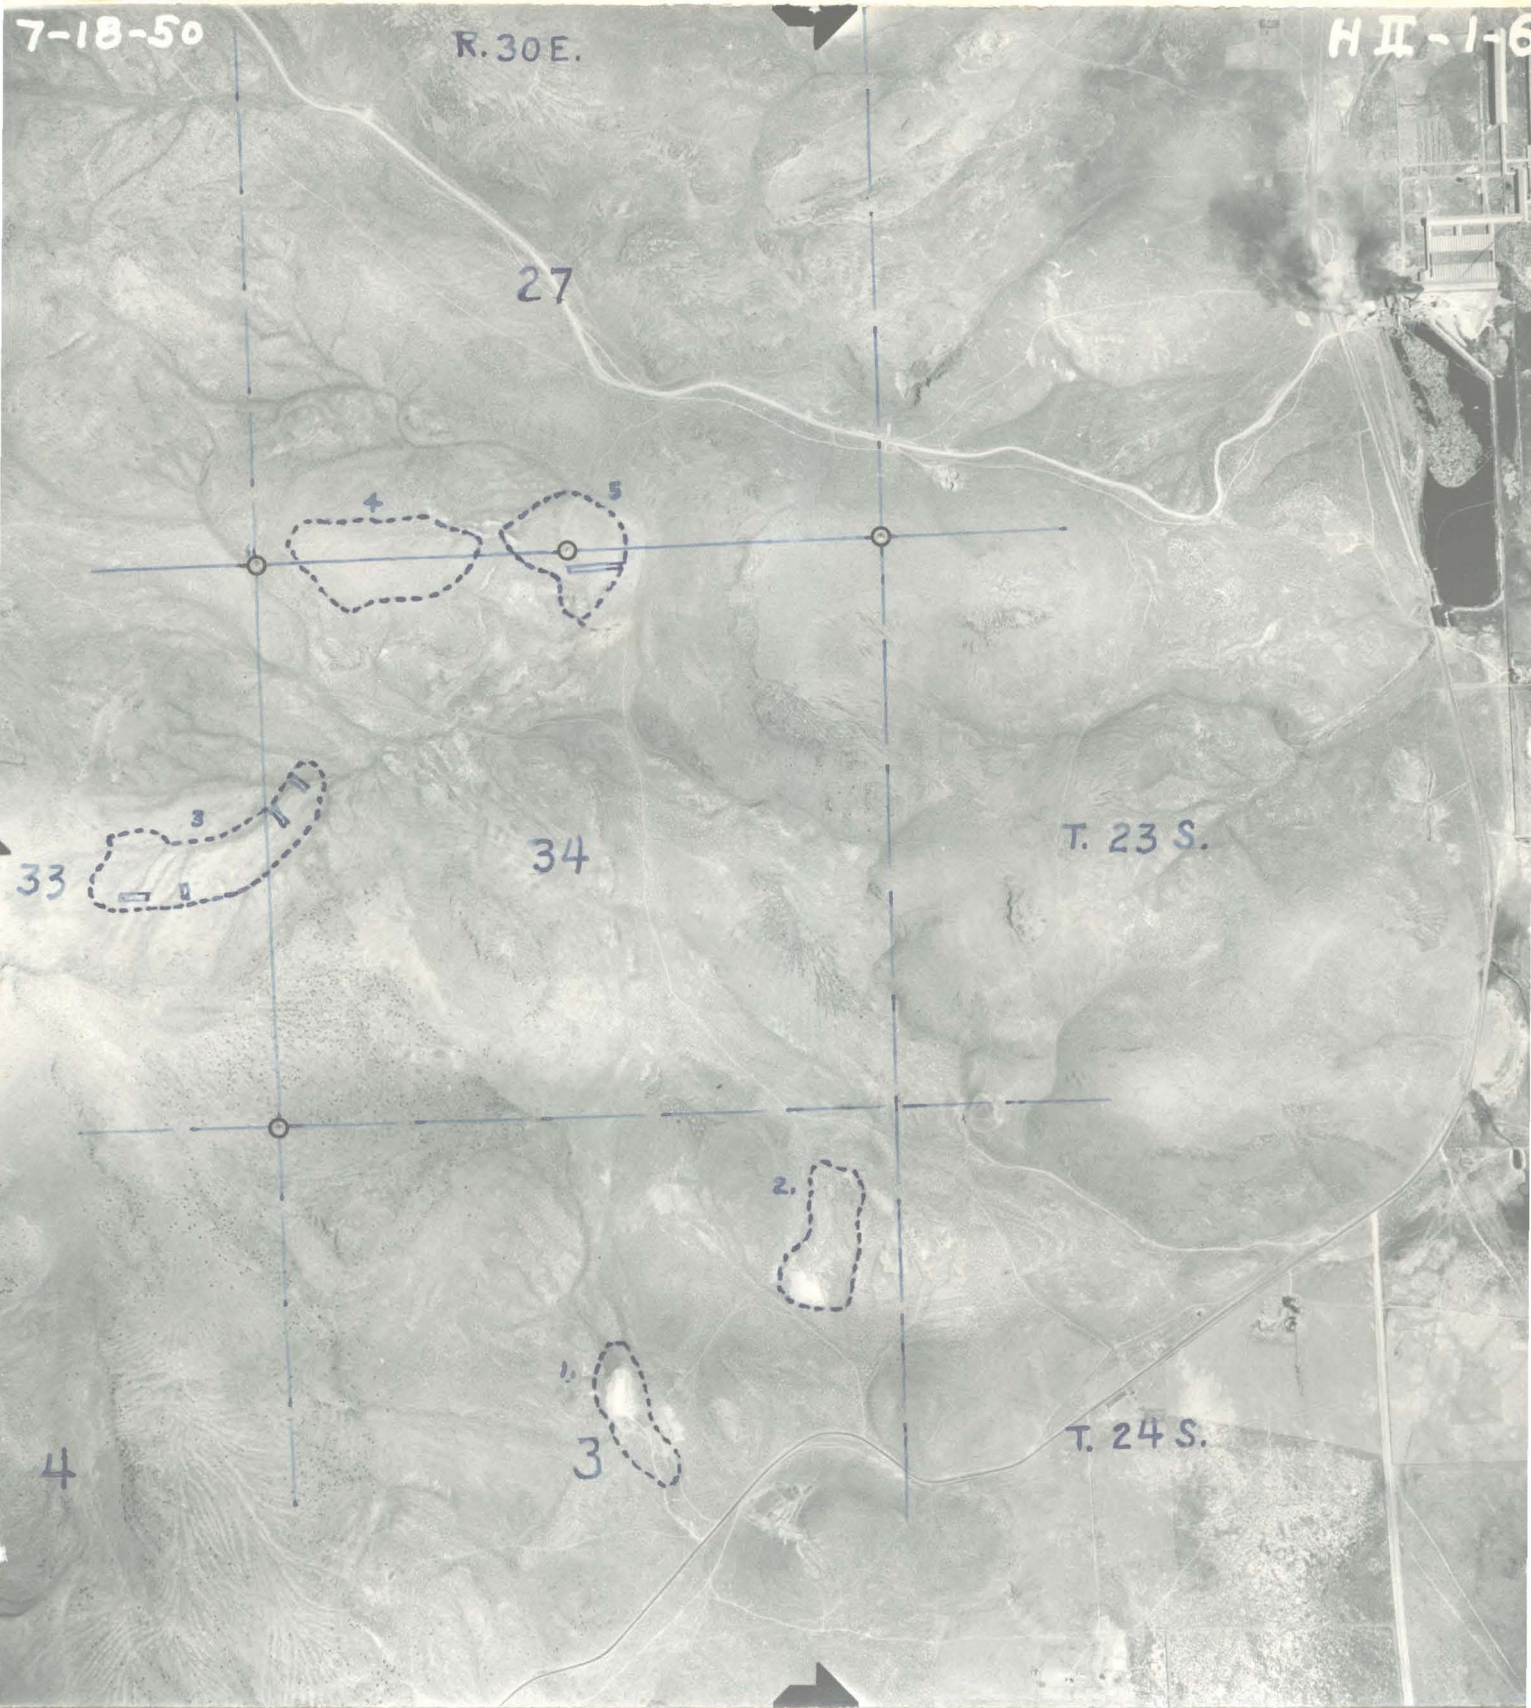
Delano Flight ----7-18-50 #HII-1-6  
P.M.A., 167 West Second South, Salt Lake City, Utah.

General: The location and approximate extent of the currently known occurrences is shown on the aerial photograph accompanying this report. These are numbered for reference purposes.

No's 1-2. No. 1 is believed to be the occurrence described in the Allen report and all past production has originated from this and the No. 2 occurrence. The original prospect workings on these occurrences has been obliterated by the mining operations and all subsequent prospecting has consisted merely of the stripping of overburden in narrow belts adjacent to the operating pit, a little at a time as mining has progressed. Neither of the occurrences are therefore adequately exposed for an overall appraisal of potential reserves and the outline of the areas as shown on the accompanying map represents inference based mostly on the observation of pumice float and topographic configuration. Dips in the surrounding area are to the east and a plunging pay horizon with attendant overburden problems can be visualized with continuing excavation in that direction, but both pits were still free of such difficulty at the time of examination, and in each case it seemed evident that expansion along a north-south line would be possible for an appreciable distance without encountering adverse mining conditions. In this respect both pits are now somewhat better than half again as large as they were when the pictures were taken.

No. 3. This occurrence is opened up by four shallow dozer cuts as shown on the map. These in no way prove the width, depth and continuity of the pumice body, but they do indicate the pumice to be of good hard, sharp quality and quite white in color. From the general lay of the land there would appear to be a good sized deposit here and much of it free of more than a token of overburden. Prospecting with depth will be necessary, however, to establish the thickness and the situation as regards interbedded ashy horizons.

No. 4. No prospecting had been done on this deposit and it was not visited accordingly. The outline shown on the map is based on the topography and Mr. Robbin's reported observations.

No. 5. The pumice in this occurrence is definitely off color to the point of being non acceptable as a block aggregate under the present standards which call for fairly white product. Otherwise it is fresh and hard. Prospecting consists of one dozer cut the length of which was not measured, but the depth of which was 21 feet at the deepest point. The length is estimated as 150 to 200 feet. Pumice was revealed from the grass roots to the bottom except for an irregular horizon of ash and clay which varied from 2 to 5 feet in thickness and which occurred at a depth of about 5 feet. Basalt and hard tuff flank the pumice on the south end and how this stands in relation to the pumice occurrence isn't clear unless it is the flank of a depositional basin.
